Early Fabric in Historic Towns Project Southwell

5 King Street (The Hen House)

Initial survey 06/03/2014

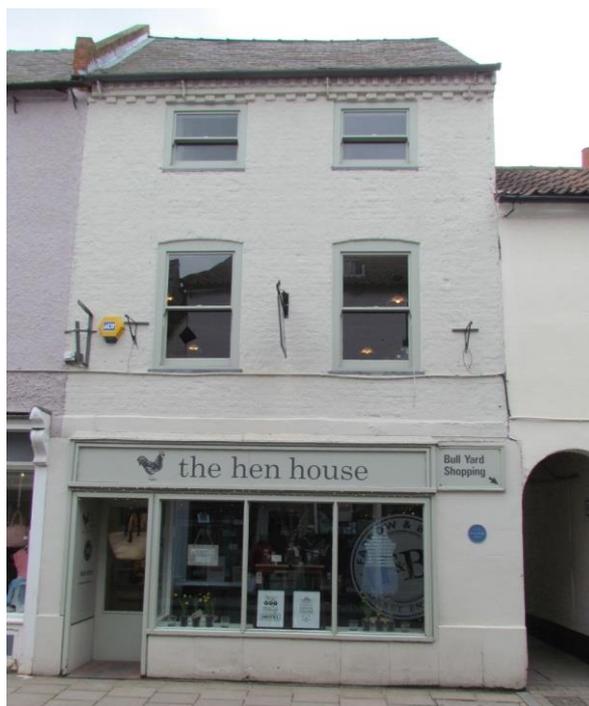
The rear projection has the remnants of a timber-frame construction, with brick façade to the northern wall,(visible via the side alleyway) which supports the original timber wall plate, which shows evidence of several large vertical mortices which housed the original tenons for substantial studs which comprised the original wall. There is clear evidence of peg holes to join original studding to the wall plate. The gabled western end of the rear of the building shows remnants of the original tie beam truss consisting of two principal rafters and a tie beam. The principal rafters each have a central butt purlin (tenoned purlin) but

no apparent ridge plate/purlin. These tenoned purlins project through the principal rafters which might suggest the original TF extended further to the west than at present. The tie beam has a rectangular excision which would appear to have accommodated a door or window light, this would have somewhat compromised the integrity of the tie. A small access door is inserted into the brick infill of the gable end. The wall posts have suffered rot at some stage and the one to the SW corner has been completely replaced by a brick column which echoes the original shape of the wooden post, even showing the shape of the original jowled or splayed head, therefore post-dating the brick infill of the gable wall. The NW wall post is similarly replaced by brick column on the lower half up to about 1.5 metres from ground level. The wall post has a jowled head where it forms a joint with the tie beam and wall plate. Again, the wall plate protrudes through the wall post perhaps suggesting a further bay extending to the west.

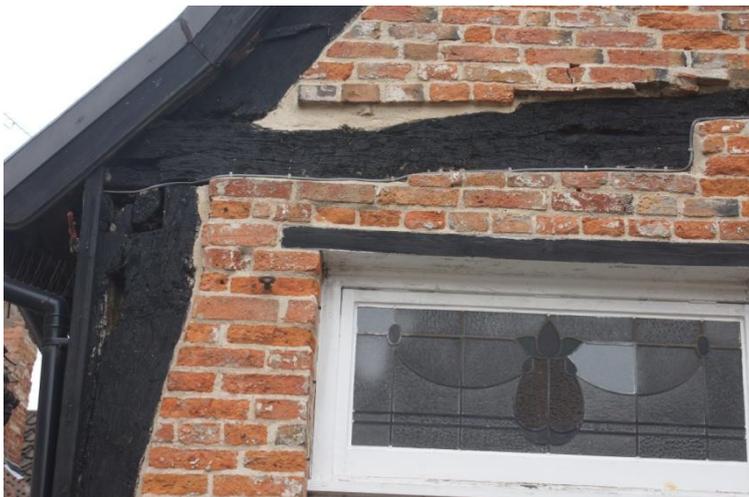
Plate 1: Detail of NW corner wall post joint showing jowled head with wall plate, tie and principal rafter, viewed looking south east.

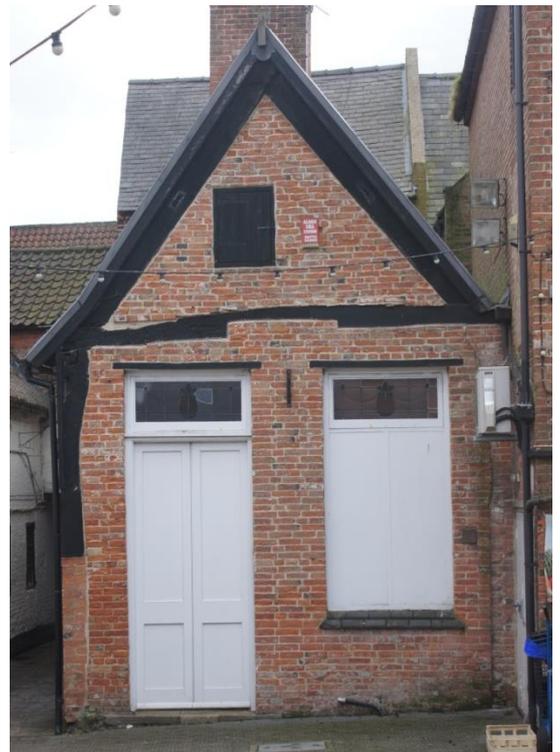
Plate 2: West facing gable end showing truss, brick infill, viewed looking south-east.

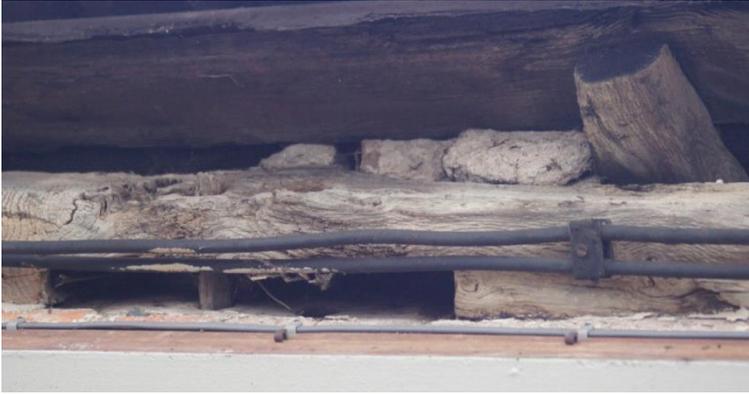
Plate 3: Detail of substantial mortice to house large wall stud in wall plate on north facing wall showing peg in situ and common rafter, viewed from beneath looking south west.

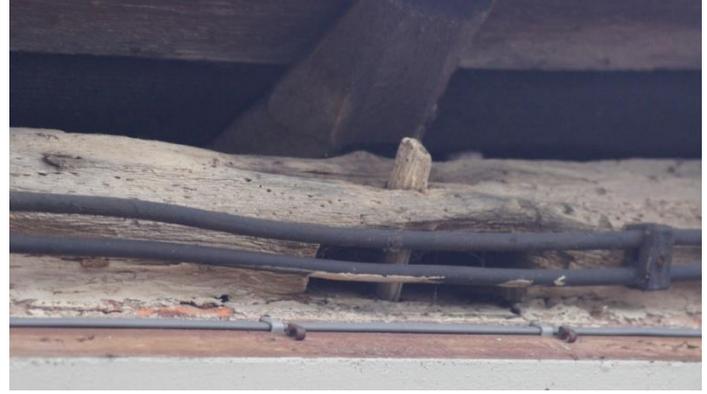
Plate 4: Detail of smaller mortice to house close studding in wall plate on north facing wall showing peg in situ, viewed from beneath looking south west.

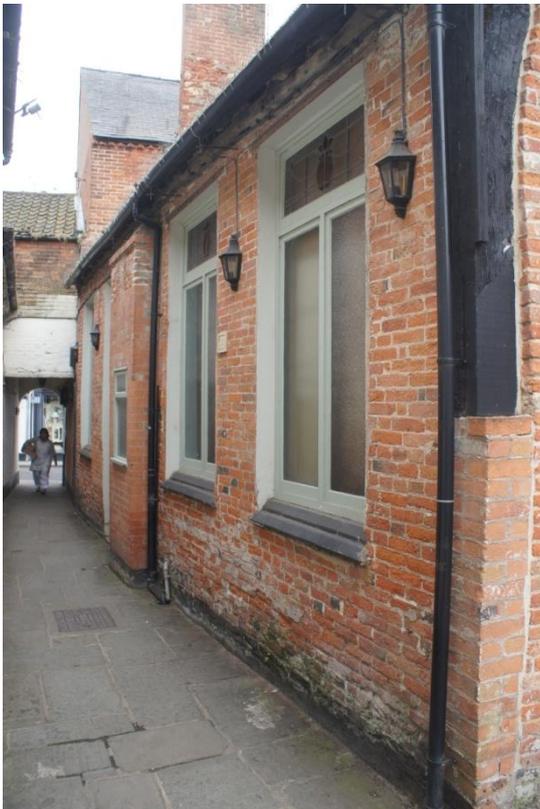
Plate 5: General view of NE facing brick façade supporting wall plate with mortices for close studding, showing brick columns replacing original wall post, viewed looking south-east.

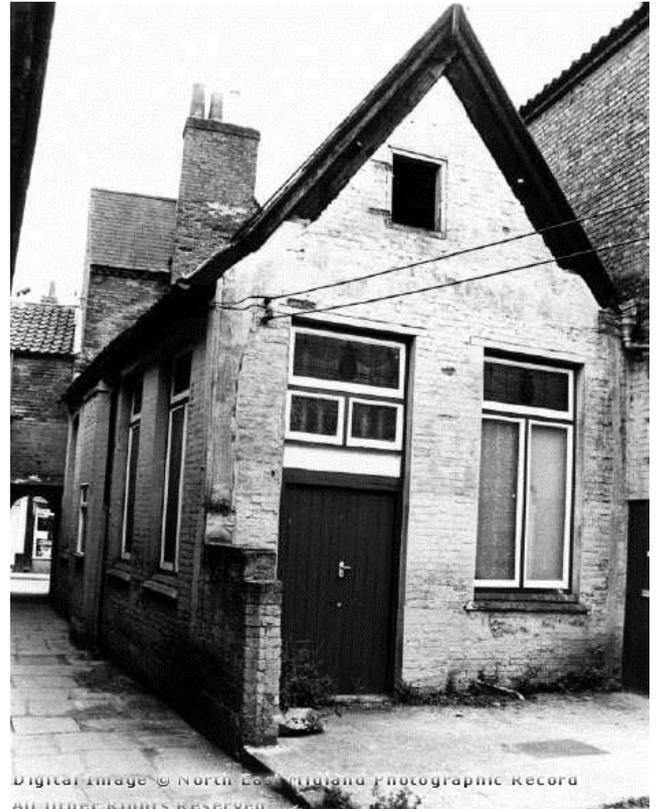
Plate 6: General view of NW facing gable supporting wall plate with TF truss obscured by render and dwarf wall projecting from N corner, viewed looking south-east. Date uncertain-copyright North East Midlands Photographic

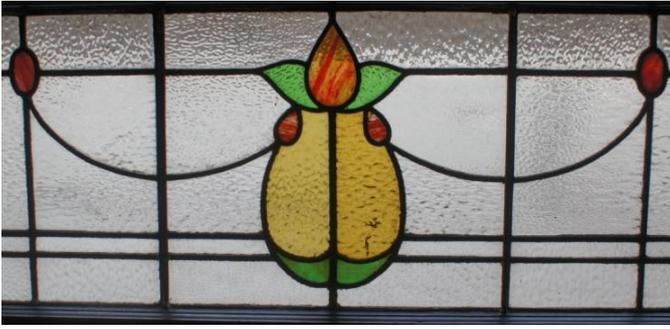
Plate 7: Victorian stain glass in TF rear extension N wall.

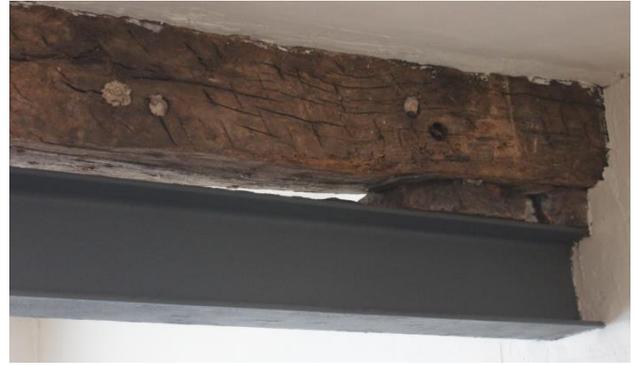
Plate 8: Detail main ceiling joist in brick built frontage, viewed looking south.
