Early Fabric in Historic Towns Project - Southwell

36 – 38 King Street, Southwell, Nottinghamshire,

Initial Survey: 13/03/2014

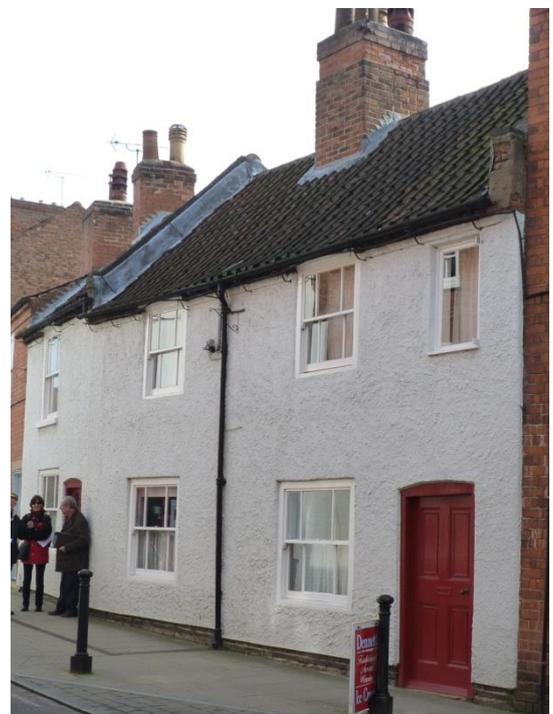
On the upper floor there are three windows, each aligned to either the windows below or the door. The windows aligned to those below are again vertical sashes with three panes above and below as before. These are also set into the dog-toothed brick corncicing in the eaves. The casement window above the door is much smaller and rectangular, possibly metal-framed and has a single pane. Unlike the others it is not set into the corncicing but is below it.

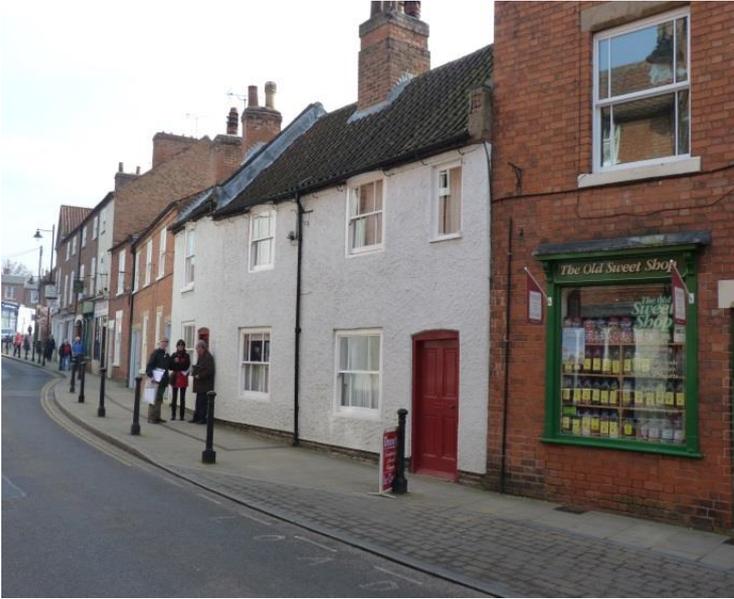
Plate 1: General View of nos 36 (nearest) and 38 King Street viewed looking east.

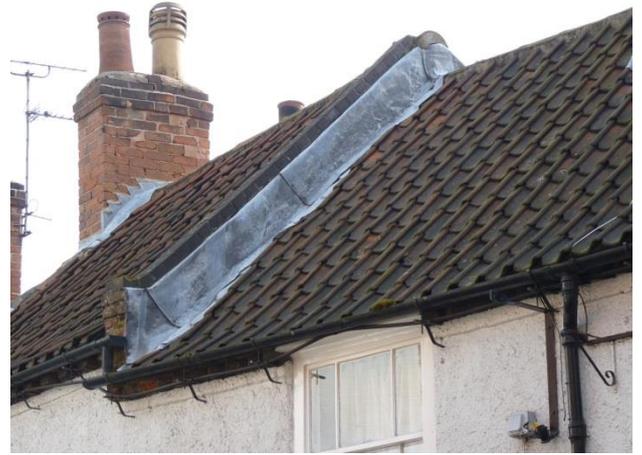
Plate 2: Sprocketed eaves and differences in roof height viewed looking east.

The building is L shaped. The original front range is a rectangular, single unit, one room deep, orientated north-east/south-west. The single ridge roof has a gable to the SW end and the roof line is higher than in the adjoining house at no. 36. The roof is composed of clay pantiles and has sprocketed eaves. There is a single stack chimney at the north-eastern end in the gable and through the roof line. The chimney has a three brick course topping. The house joins with that of no. 36 at an angle and the roof slopes slightly from west to east. The western gable has a brick raised parapet with a small kneeler and is finished with brick coping and lead flashing as it joins the roof of no. 36.

The house is a rectangular two unit building one room deep and orientated at a slight angle to its neighbour no. 38. The roof is gabled and composed of clay pantiles. It is lower than that of no. 38 but has a brick parapet at the western end with lead flashing and a small brick kneeler similar to that of no. 38.

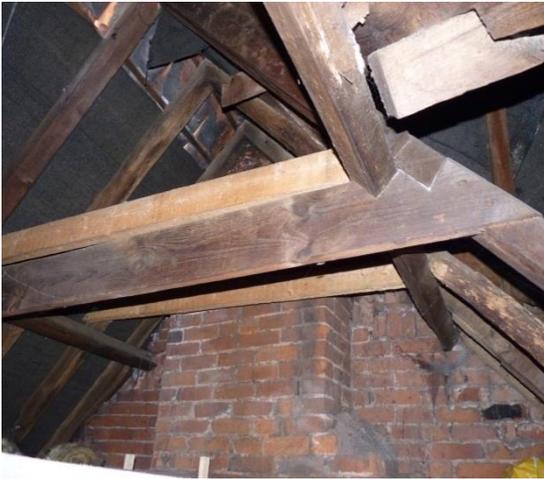
Plate 3: Clapsed Purlins in Roof Space of no.38 viewed looking north-east.

The roof was constructed of principal rafters with clasped purlins; some of the rafters had been re-used and were clearly much older than others. Most of the timbers were of relatively modern origin with machine sawn evidence. The re-roofing may have been done at the same time as the rear extension. The brick dividing partition between nos 38 and 36 was present in the roof space; the bricks did not appear to be old.

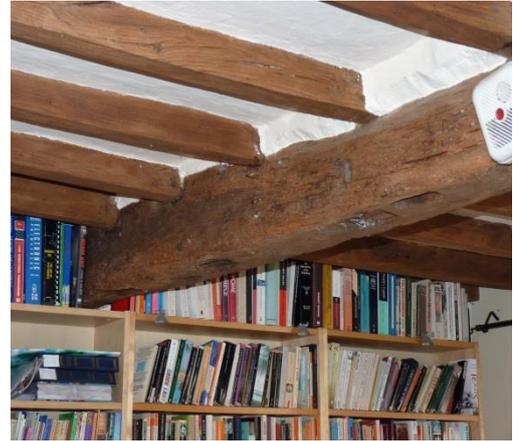
Plate 4: Internal of no.38 showing mortised beam.

Above the fireplace in the main room is a wooden bressummer, embedded in brick and supporting an old, oak beam running roughly east-west through the house and not across it. The beam is unchamfered but has a number of mortices cut on the underside and shallow, angled cut-outs between mortices. These latter were probably cut to house the base of rafter so the beam is probably a re-used wall-plate. It may have been re-used twice since the

mortices have no obvious role in the current house; they may have housed studding timbers. The current use therefore suggests at least a third phase of use.

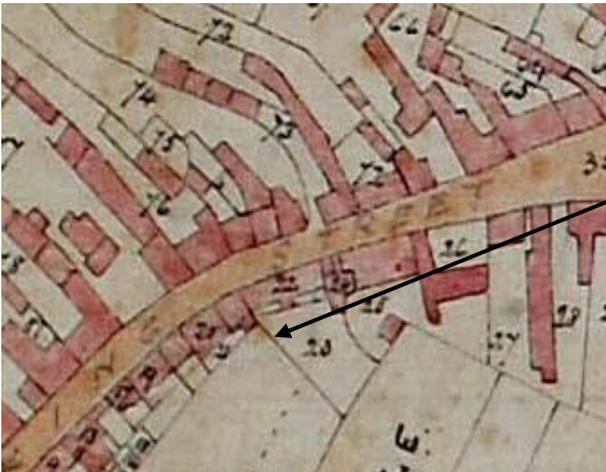
Plate 5: 1841 Tithe Map Showing position of Properties.

36 & 38 King Street appear on the 1841 Tithe Map [1] at location 20 and 21 and are described as houses, premises and a yard. One owned by Sarah Hind with one occupied by William Swift and the other by George Geeson and others.
